NASA TECHNICAL NOTE

NASA TN D-563

INVESTIGATION OF S-IV ALL SYSTEMS VEHICLE EXPLOSION

Compiled and edited by J. B. Gayle

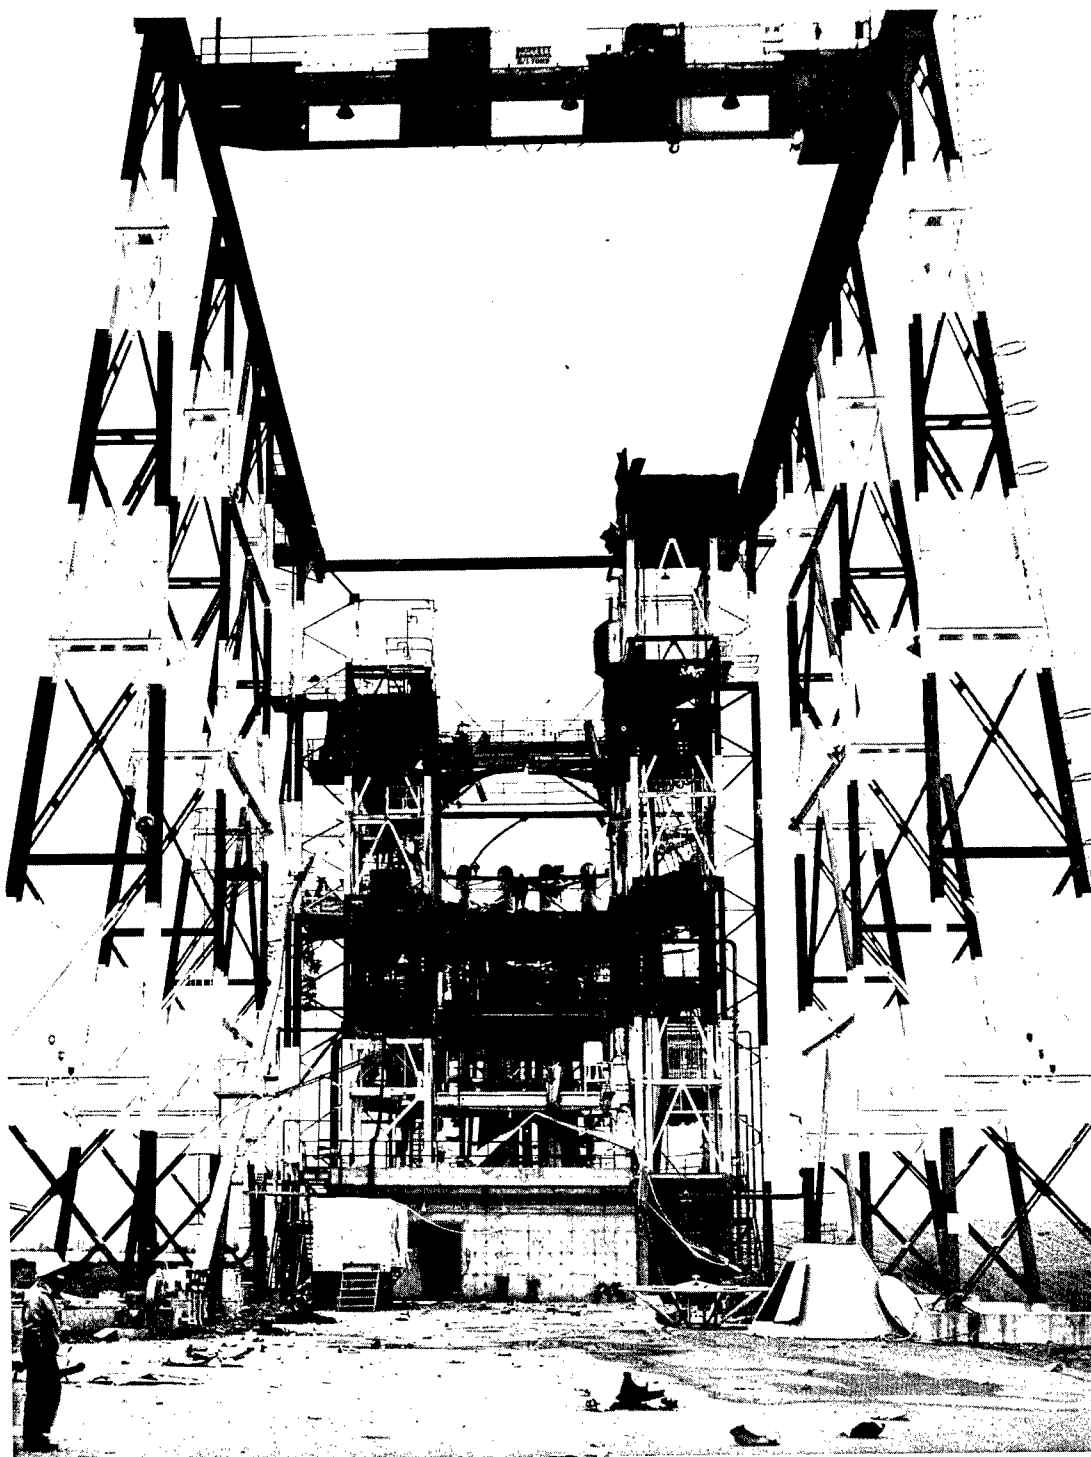
FIGURE 2. VIEW OF TEST STAND AFTER EXPLOSION

Figure 2 shows the test stand and vicinity after the explosion. Inspection of this figure indicates that the overhead crane and supporting structures were virtually undamaged and that the effects of the explosion were largely confined to the test stand proper.

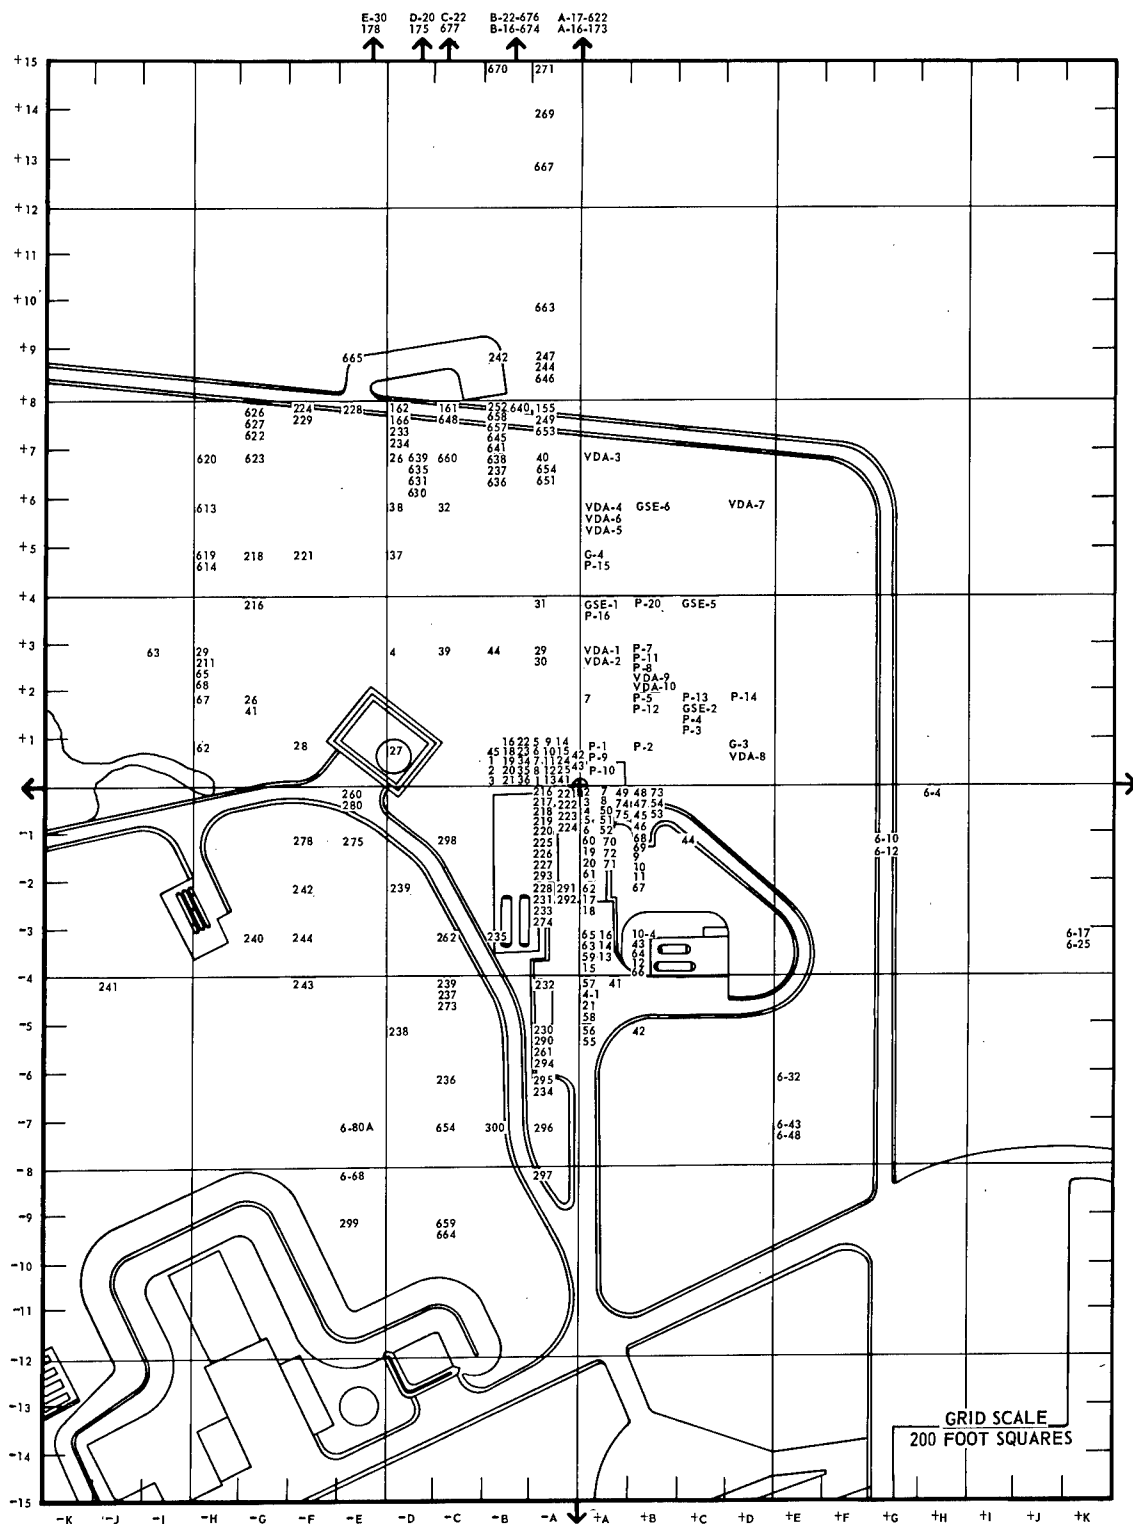
Figure 3 is a map showing the location of debris which was dispersed as shrapnel. Table II gives the identification of the fragments shown on FIG 3. Table III is a tabulation of the approximate sizes, weights, and locations (in distance from the center of the explosion) of fragments selected for possible detailed investigation.

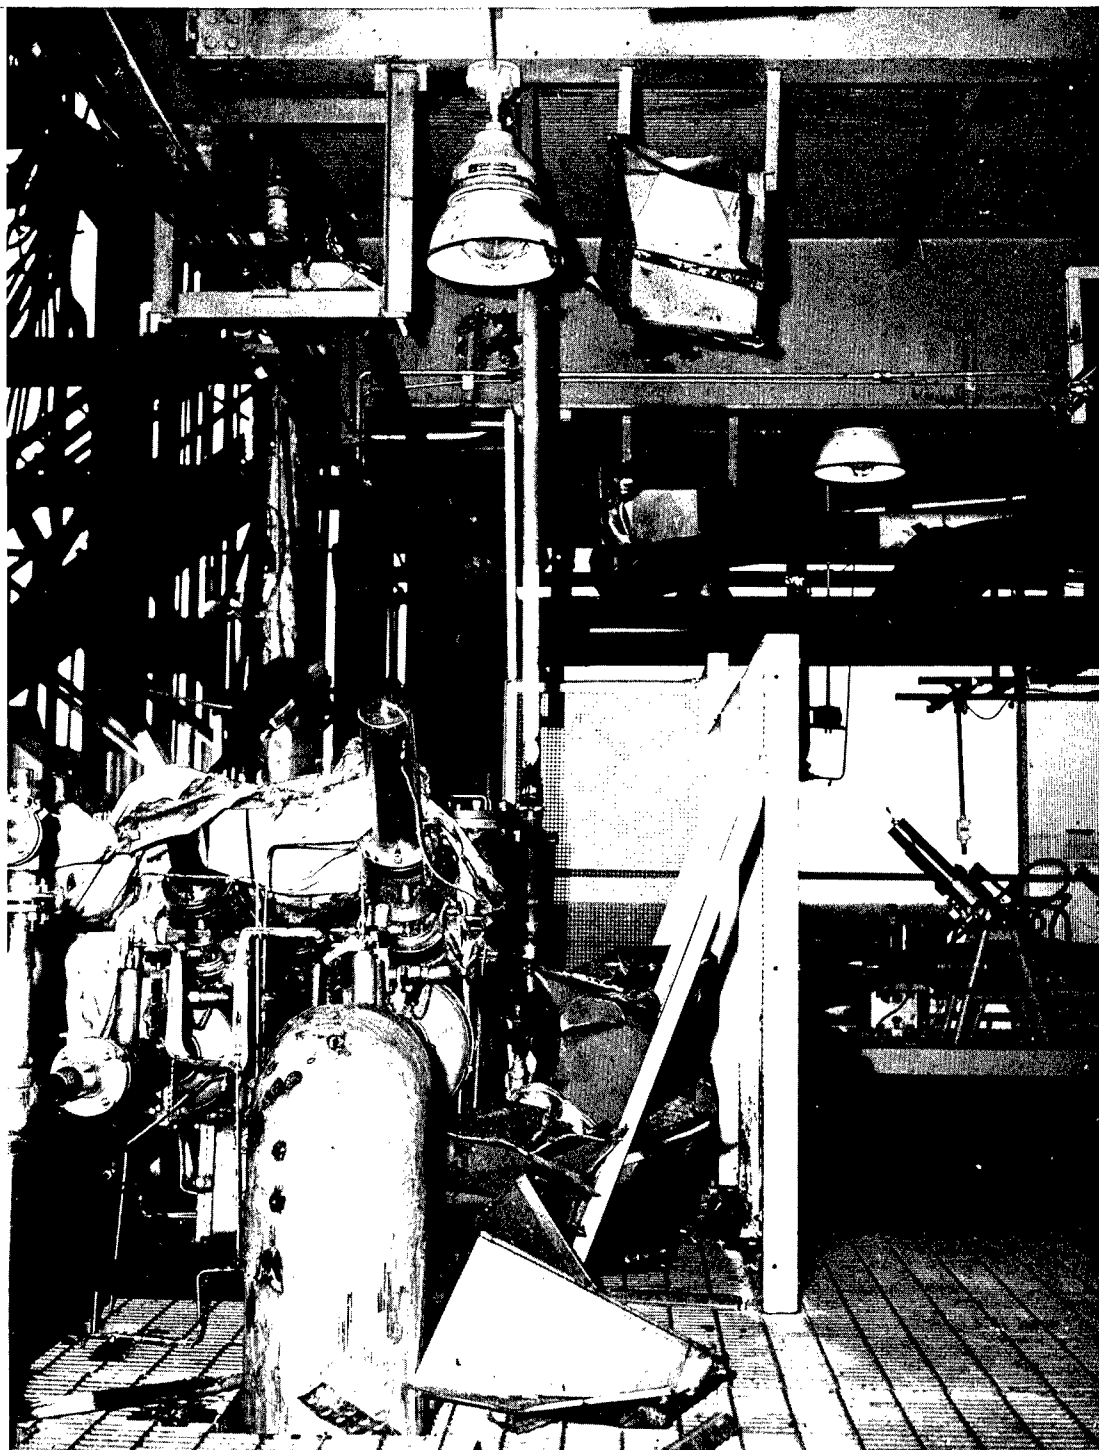
FIGURE 6. LIQUID HYDROGEN AND OXYGEN SLEDS (3rd LEVEL)

The liquid oxygen sled did not appear damaged. On the liquid hydrogen sled, flammable foam insulation was burned and valve handles were singed, but damage appeared inconsequential (FIG 6).
